June 12, 2012

**Re: GE-Pittsfield/Housatonic River Site
East Street Area 2-North
TSCA CAO No. 01-2002-0049
Building 9 Sub-Vault – Revised Cleanup Plan**

GENERAL ELECTRIC COMPANY
 PITTSFIELD, MASSACHUSETTS
BUILDING 9 SUB-VAULT CLEANUP PLAN

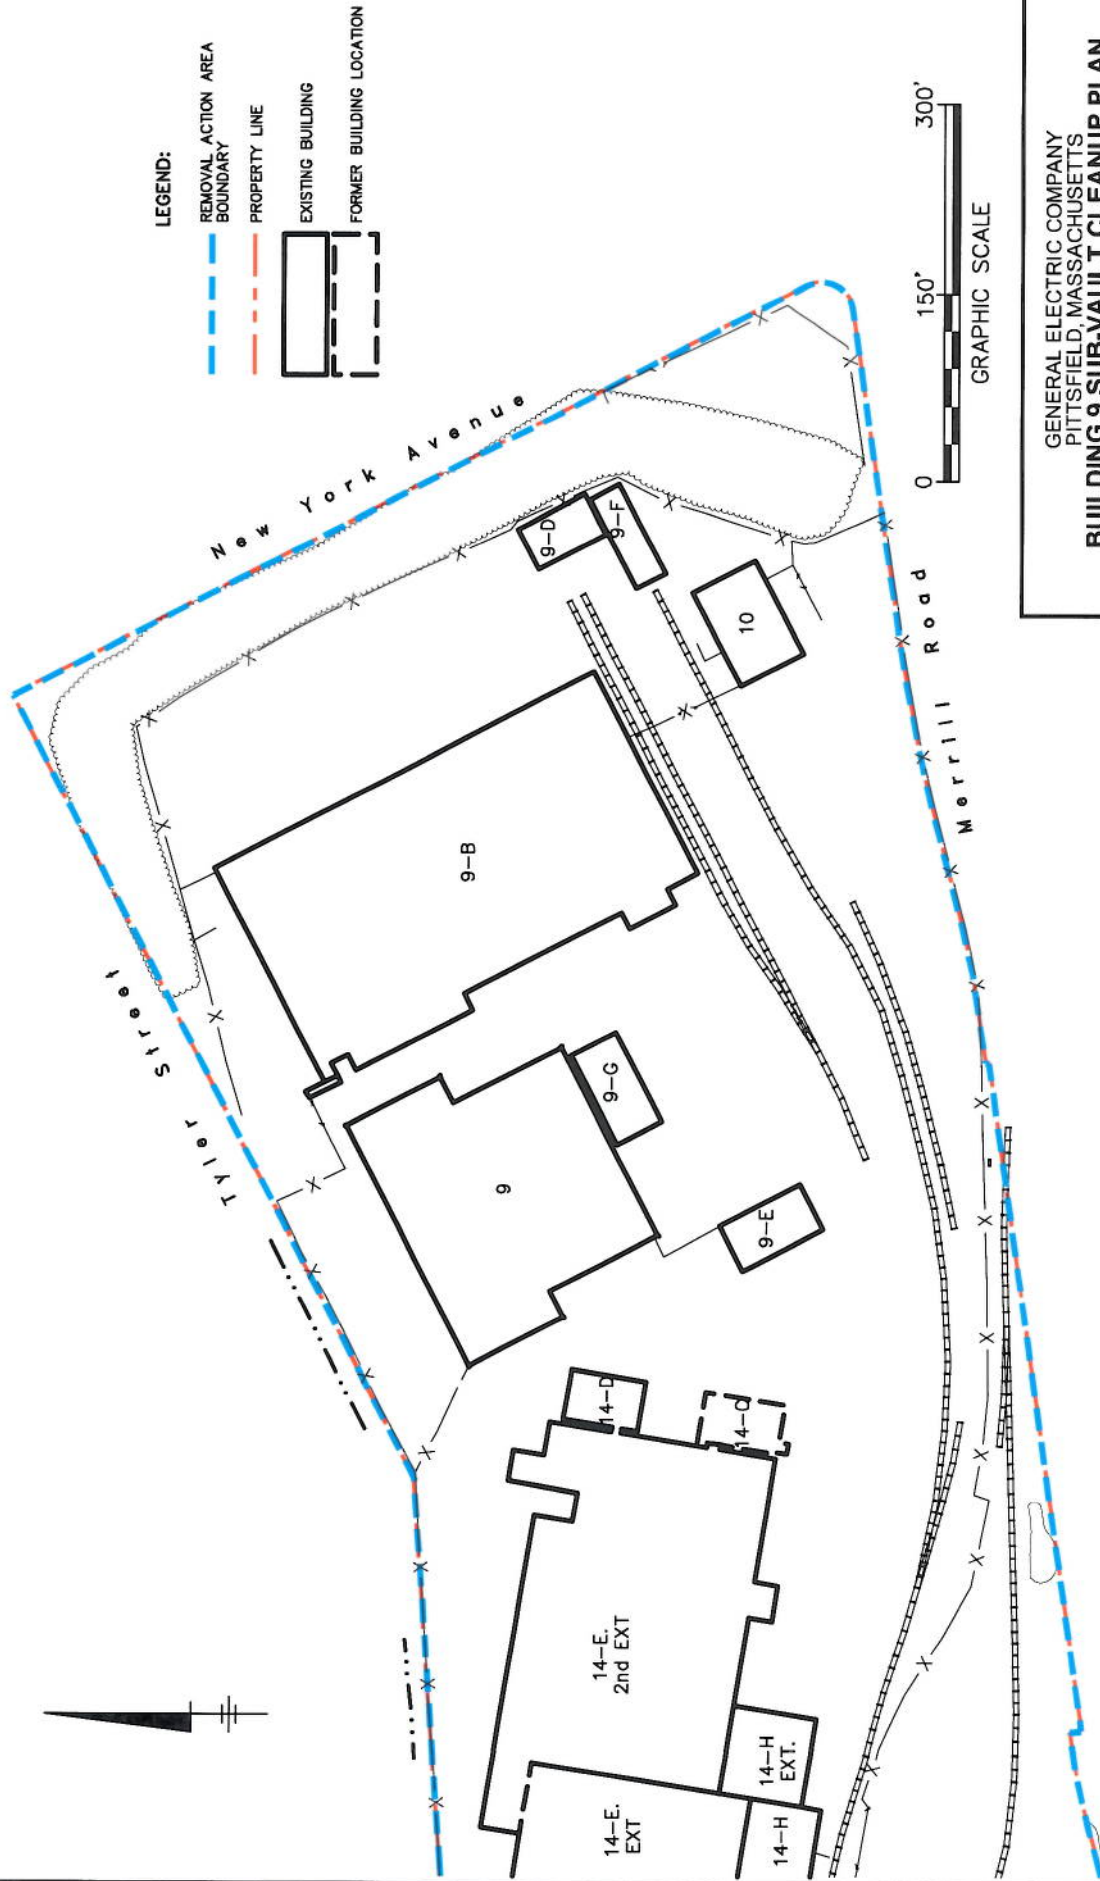
FIGURE
1

located beneath the leaking transformer for transport to and storage at GE's on-site TSCA storage facility. The containerized items were subsequently transported off-site for disposition at appropriately permitted disposal facilities. Figure 2 shows the general location of the sub-vault area and the specific sub-vault where oil leakage was identified.

Building 9 is located in the eastern half of East Street Area 2-North (Figure 1). Building 9 was originally constructed in 1947 and was utilized by GE's Power Transformer Department through the early 1990s. The sub-vault which contained the leaking PCB transformer is located in the northwest corner of Building 9, as shown on Figure 2. Several characterization activities have been performed in the vicinity of the Building 9 sub-vault, including soil and groundwater sampling conducted pursuant to the CD, as well as the recent sampling and analysis of the concrete floor within the sub-vault itself. A summary of these activities is provided below.

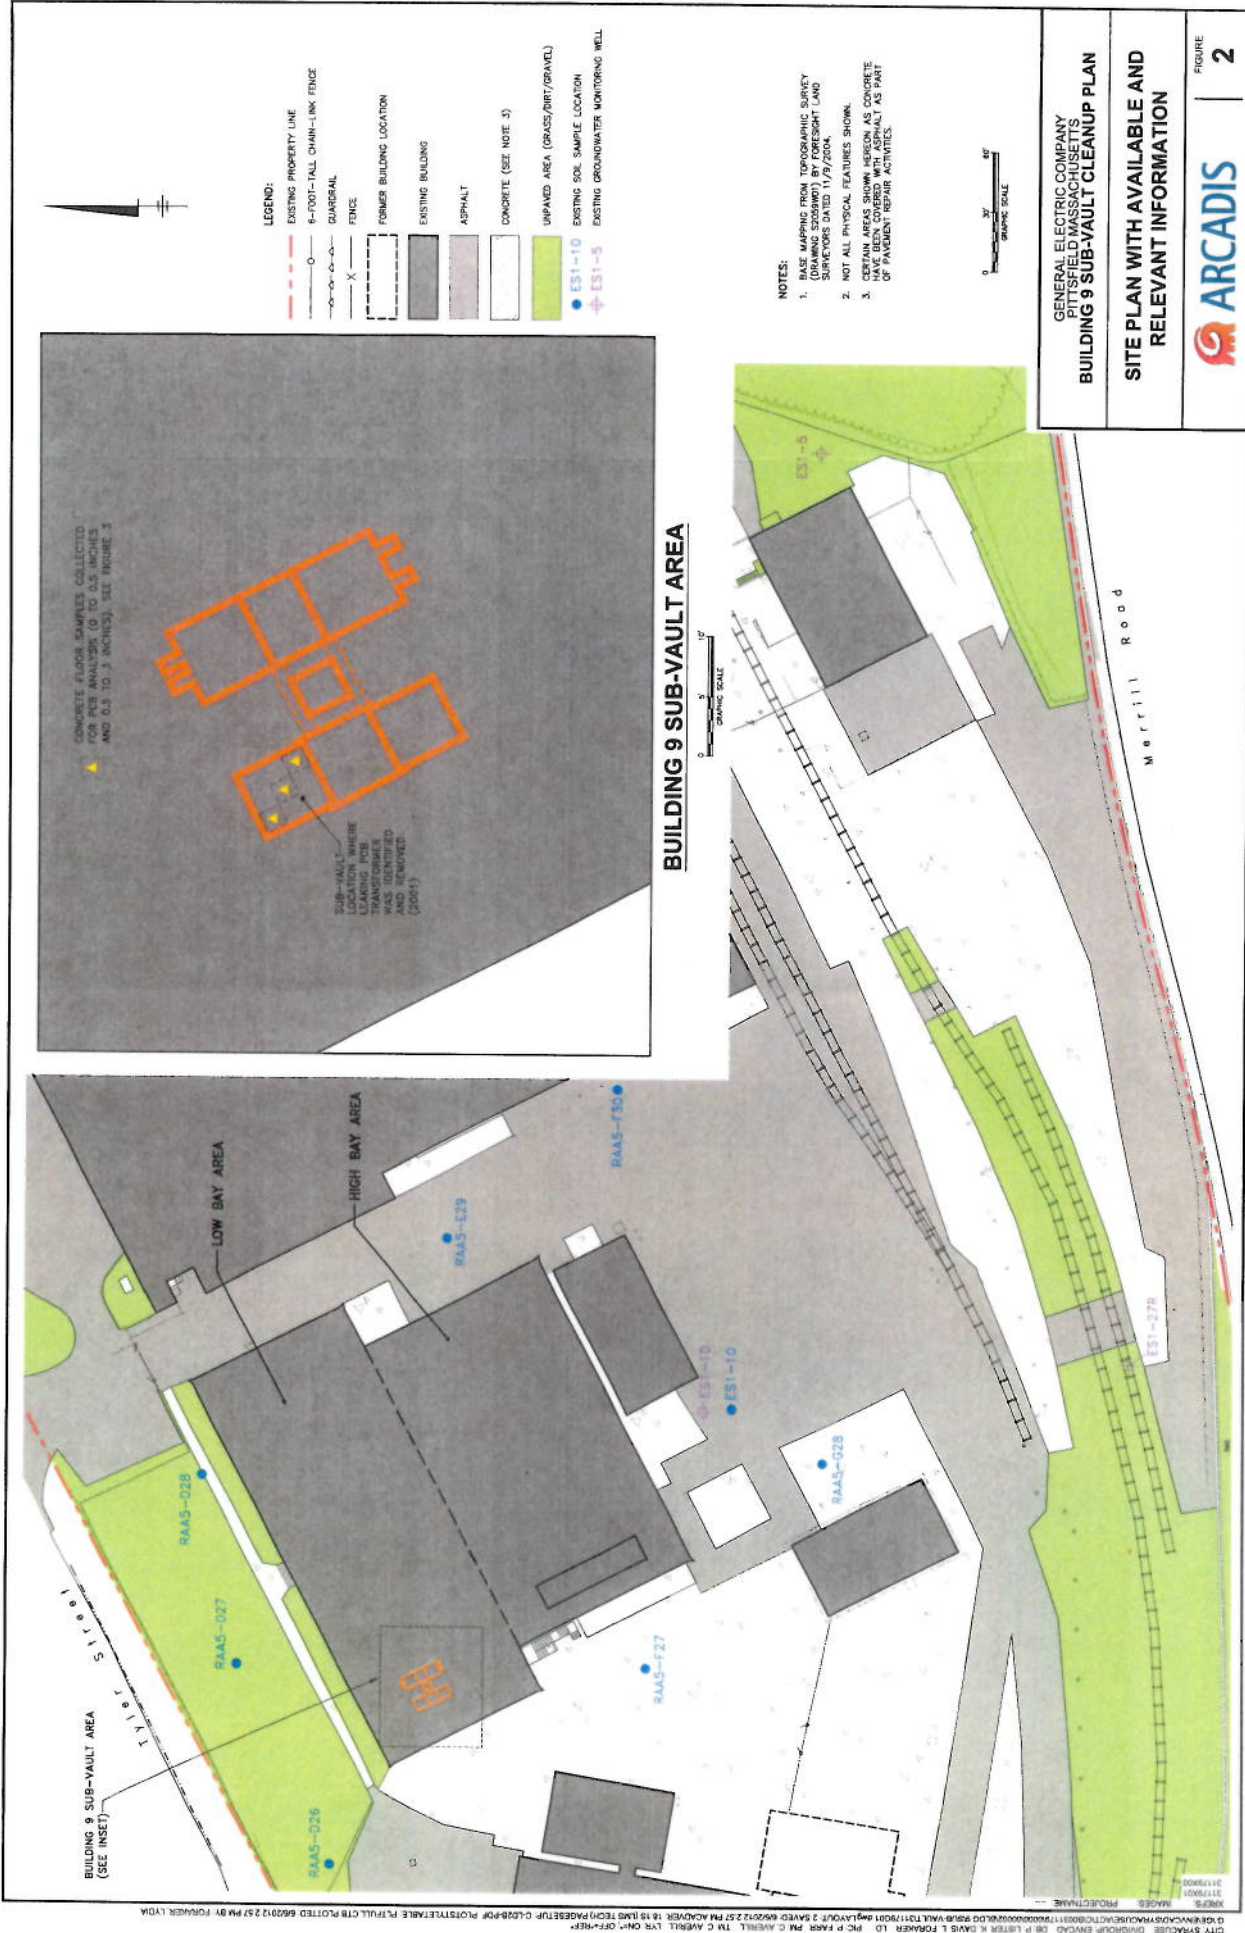
FIGURE
2

With respect to groundwater, the most relevant groundwater monitoring locations are ES1-10, ES1-5, and ES1-27R, as shown on Figure 2. In general, the Performance Standards for groundwater quality are based on the groundwater classification categories designated in the Massachusetts Contingency Plan (MCP). Groundwater from monitoring well ES1-10, which is the closest to Building 9, is classified as both GW-2 (constituting a potential source of vapor intrusion into the indoor air of nearby buildings) and GW-3 (constituting a potential source of discharge to surface water). Groundwater from monitoring well ES1-5 and ES1-27R is classified as GW-3.

Filtered PCB data collected from October 2001 through April 2008 from these monitoring wells are summarized in Table 2. These data have been compared to the applicable MCP Method 1 groundwater standards.² The PCB concentrations in the samples from monitoring well ES1-10 were all non-detect (and thus necessarily below the applicable Method 1 GW-2 and GW-3 standards for PCBs, which are 0.005 and 0.01 ppm, respectively). The PCB concentrations in the samples from monitoring wells ES1-5 and ES1-27R ranged from non-detect to 0.00226 ppm, all of which are below the MCP Method 1 GW-3 groundwater standard of 0.01 ppm for PCBs. Furthermore, from January 2001 to the present, there have been no observations of non-aqueous phase liquid (NAPL) in groundwater monitoring wells ES1-5, ES1-10 and ES1-27R.

The information summarized above indicates that the Building 9 sub-vault where the leaking PCB transformer was found is not a source of PCBs to surrounding soil and groundwater.

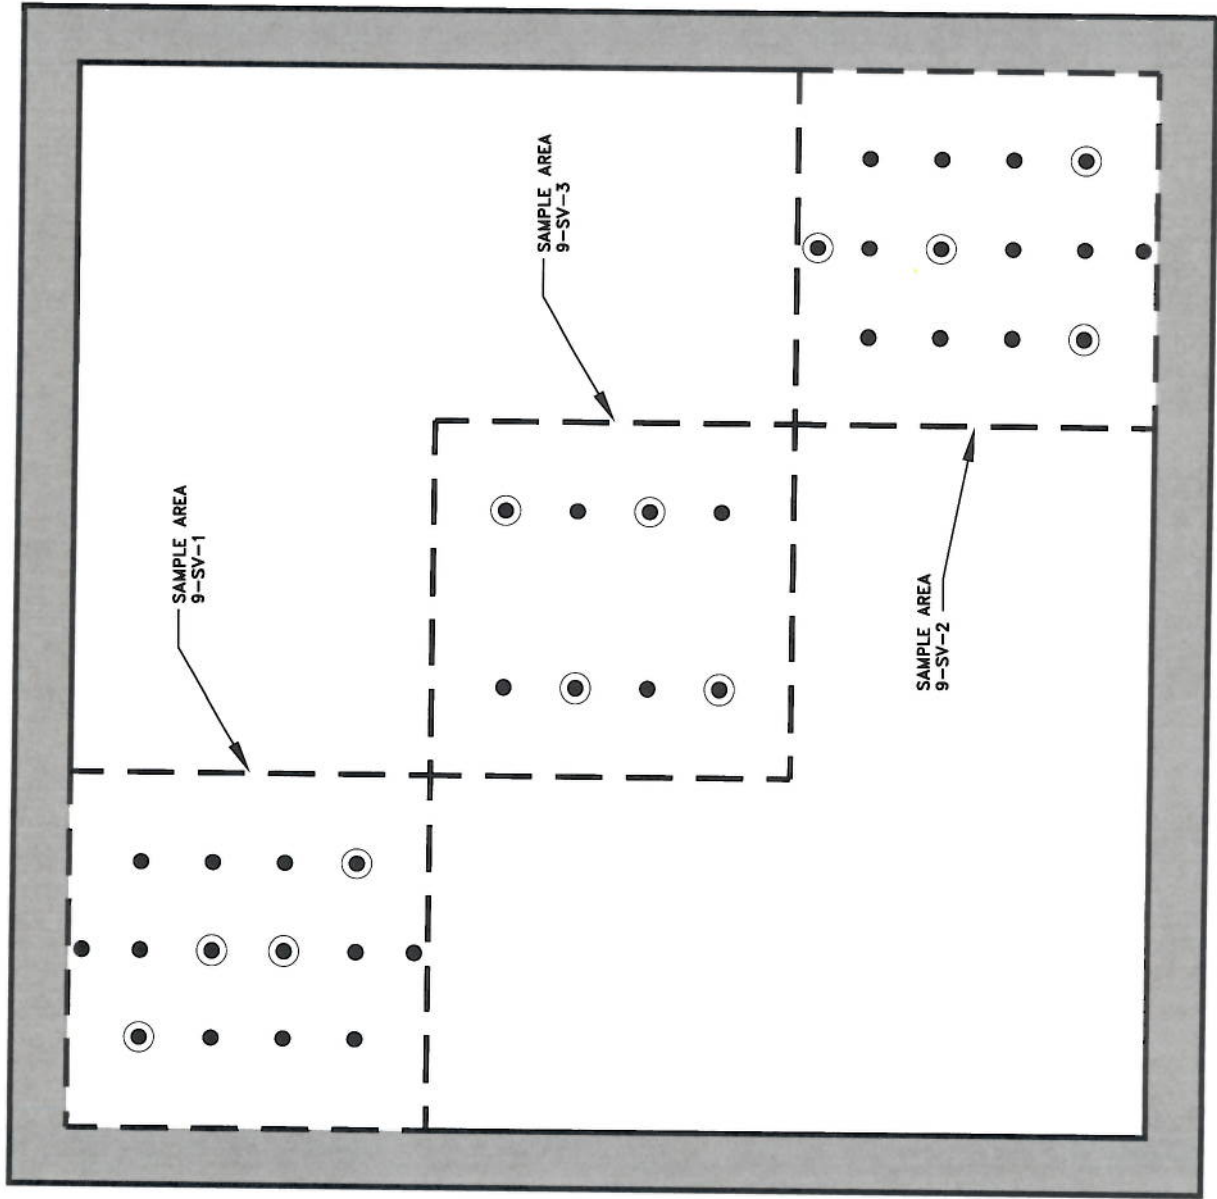
**APRIL 2012 BUILDING 9 SUB-VAULT
 CONCRETE FLOOR SAMPLING**

More recently, GE performed sampling and analysis of the sub-vault concrete floor. This activity was required by EPA based on its review of the January 16, 2012 version of this cleanup plan and included use of specific EPA Region 1 sampling protocols (i.e., *Standard Operating Procedure for Sampling Porous Surfaces for Polychlorinated Biphenyls*; May 2011). Following discussions related to the scope of the sampling and analysis activities, GE conducted the sampling on April 17, 2012. Samples were collected from three floor areas within the sub-vault, including one area where the leaking PCB transformer was located (Sample Area 9-SV-1). Within each area, samples were collected from several locations at depth increments of 0 to 0.5 inch and 0.5 to 3 inches, and the samples from each depth increment were composited into a single sample for analysis. Analysis of the three composite samples from the uppermost depth increment was performed initially; based on these results, the composite samples collected from the 0.5- to 3-inch depth increment were then analyzed. The sampling areas and locations are presented on Figure 3, a summary of the analytical results is presented below (duplicate sample result in parentheses), and the analytical laboratory data sheets are included as Attachment 1:

<u>Sample Area</u>	<u>Depth Increment (inches)</u>	<u>PCB Result (ppm)</u>
9-SV-1	0.0 – 0.5	3,350
9-SV-1	0.5 – 3.0	58.7
9-SV-2	0.0 – 0.5	489 (861)
9-SV-2	0.5 – 3.0	238
9-SV-3	0.0 – 0.5	8,500
9-SV-3	0.5 – 3.0	64.4

Based on the above data, the average PCB concentration in the surface of the concrete floor (0- to 0.5 depth) is 4,175 ppm, while the underlying depth increment from 0.5 to 3 inches has an average PCB concentration of 120 ppm, or approximately 3% of the overlying average PCB concentration. This decreasing trend in PCB concentrations, coupled with a concrete floor slab thickness of approximately

12 inches (based on review of historic information), further supports the conclusion from the review of the soil and groundwater data in the vicinity of Building 9 – i.e., that the leaking transformer was not a source of PCBs to the environment.

As noted above, in 2001-02, GE removed the tar-like residue from what is believed to have been a release of approximately two gallons of dielectric fluid, and double-washed, double-rinsed, and double-painted the sub-vault where the release occurred. GE proposes to complete the cleanup of the sub-vault that contained the leaking PCB transformer by: (a) removing at least the uppermost three inches of the sub-vault's concrete floor for disposal as TSCA-regulated waste; and then (b) filling the entire sub-vault with concrete to match the adjacent Building 9 floor elevation (a depth of approximately 9 feet) to fully isolate, and prevent future contact with or exposure to, the sub-vault interior. These activities will be fully documented and will be performed in conjunction with the overall demolition of the Building 9 and 10 Complex.

5. The additional measures proposed in this cleanup plan will provide further assurance that the condition of no unreasonable risk of injury is maintained in the future. Removing the uppermost three inches of the sub-vault concrete floor and then filling the sub-vault with approximately 9 feet of concrete (to be coordinated with the overall demolition of Building 9 and 10 Complex) will protect against any future exposure to or migration of any remaining PCBs in the sub-vault, thus preventing an unreasonable risk.
